SUB-SLAB FLUSHING & RECOVERY OF No. 2 FUEL OIL

HUDSON VALLEY, NEW YORK

AUGUST 2020

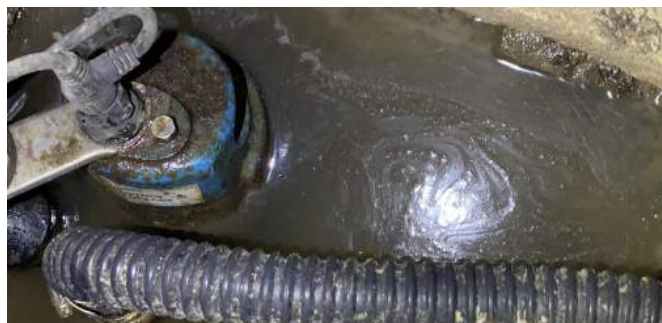
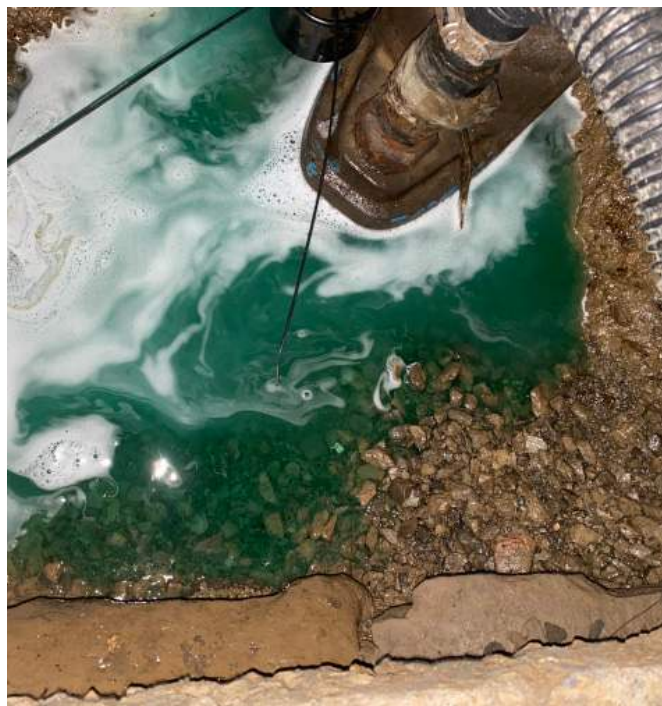
A number two fuel oil release occurred from an exterior tank of a residence, contaminating the soils surrounding the tank as well as under the adjacent basement floor slab. The excavatable soil was removed for offsite disposal and a remediation plan was put in place for the remaining areas. Through a series of holes and PVC injection points, a 3% solution of EcoGreen was flushed underneath the slab and all fluids were directed toward a collection point in the basement sump for recovery and disposal. Approximately 2,000 gallons of EcoGreen solution were injected under the basement floor slab over the course of two flushes. Efficacy screening and soil samples were collected after the remediation, confirming that the EcoGreen treatment had been successful in both the remediation and in vapor suppression. In total, over 8,000 gallons of the oily water mixture were collected and transported offsite to be properly disposed of.
